Monitoring of Forestry BMPs in Michigan Fall 2014

*Prepared by Dr. Larry Pedersen
For the Michigan Sustainable Forestry Initiative Implementation Committee
December, 2014*

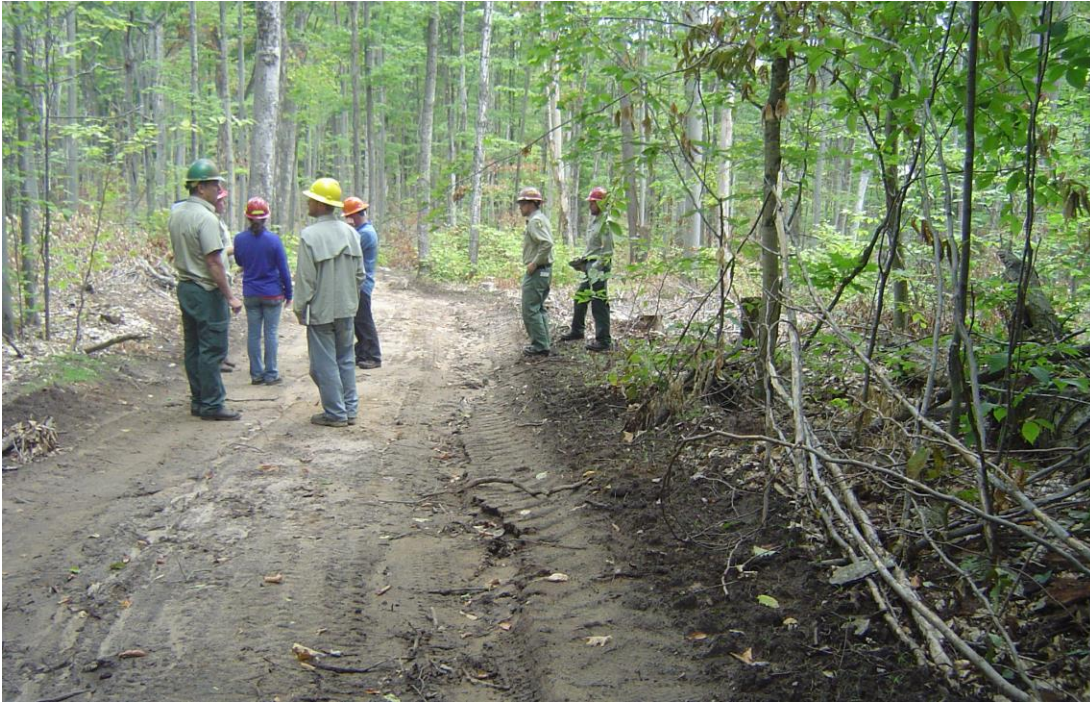
The audit team discussing the needs of a skid road for stabilization and closure.

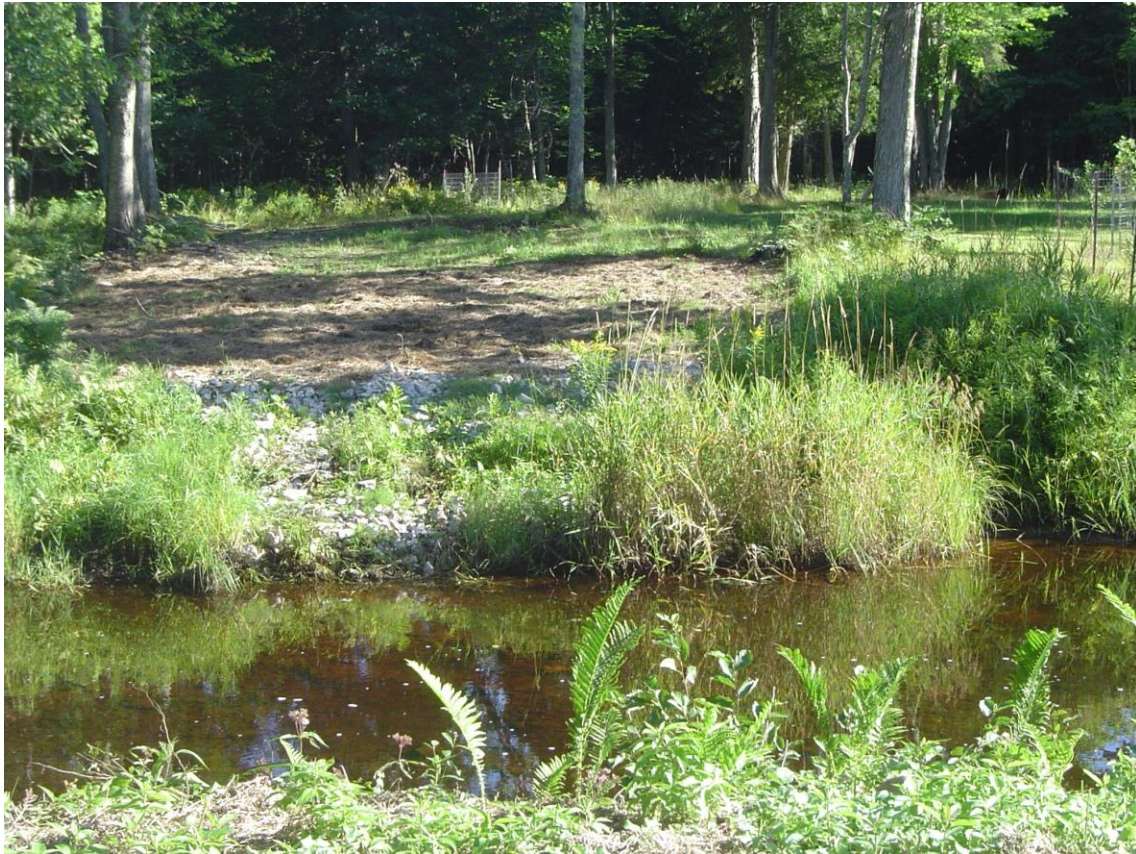
Temporary crossing; bridge was placed and removed twice for winter logging with no damage to bank; approach was then seeded and mulched.

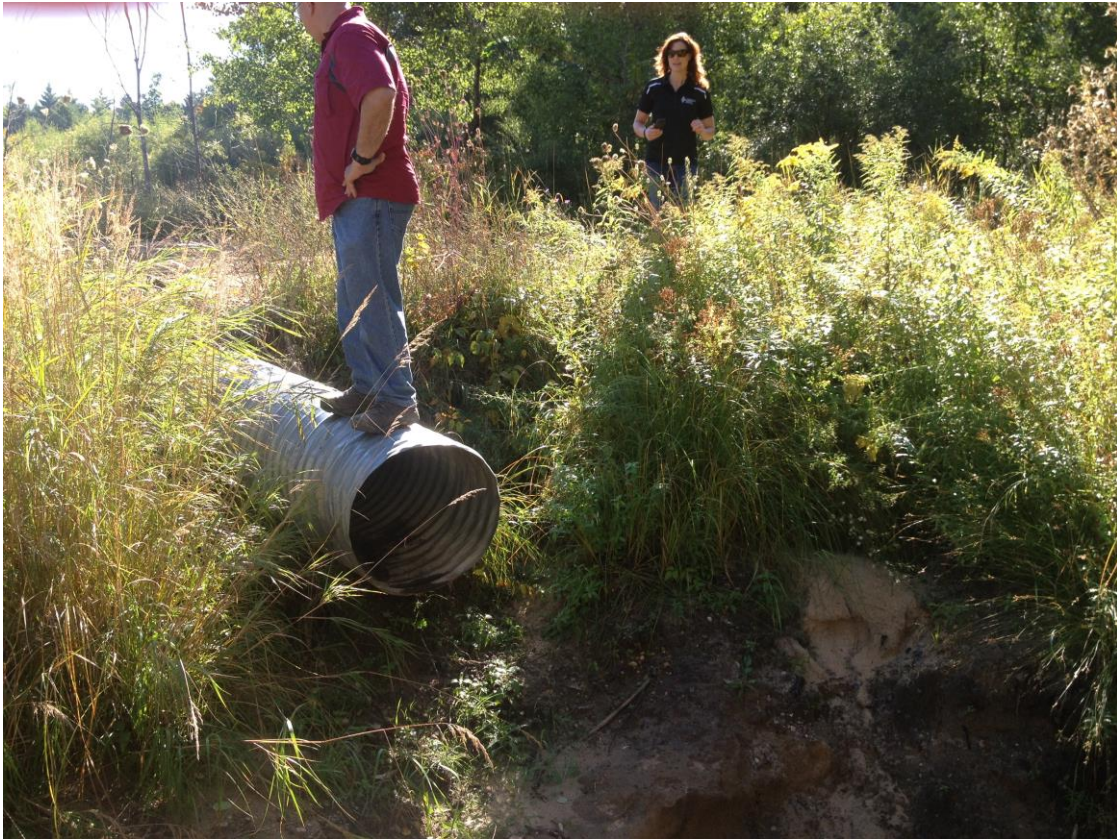
Auditors examining badly perched culvert.

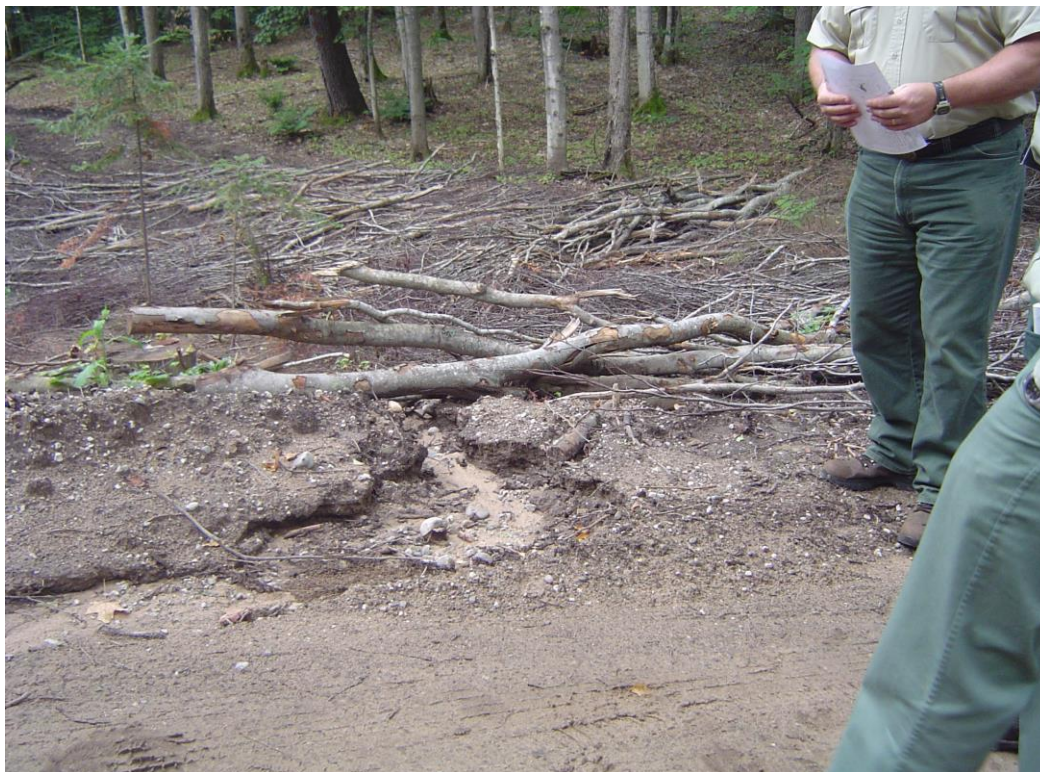
Slash ineffective in controlling run-off from road
